ECR #: P1

Title: Correction to Figure 3.17

Spec Version: NLX 1.2

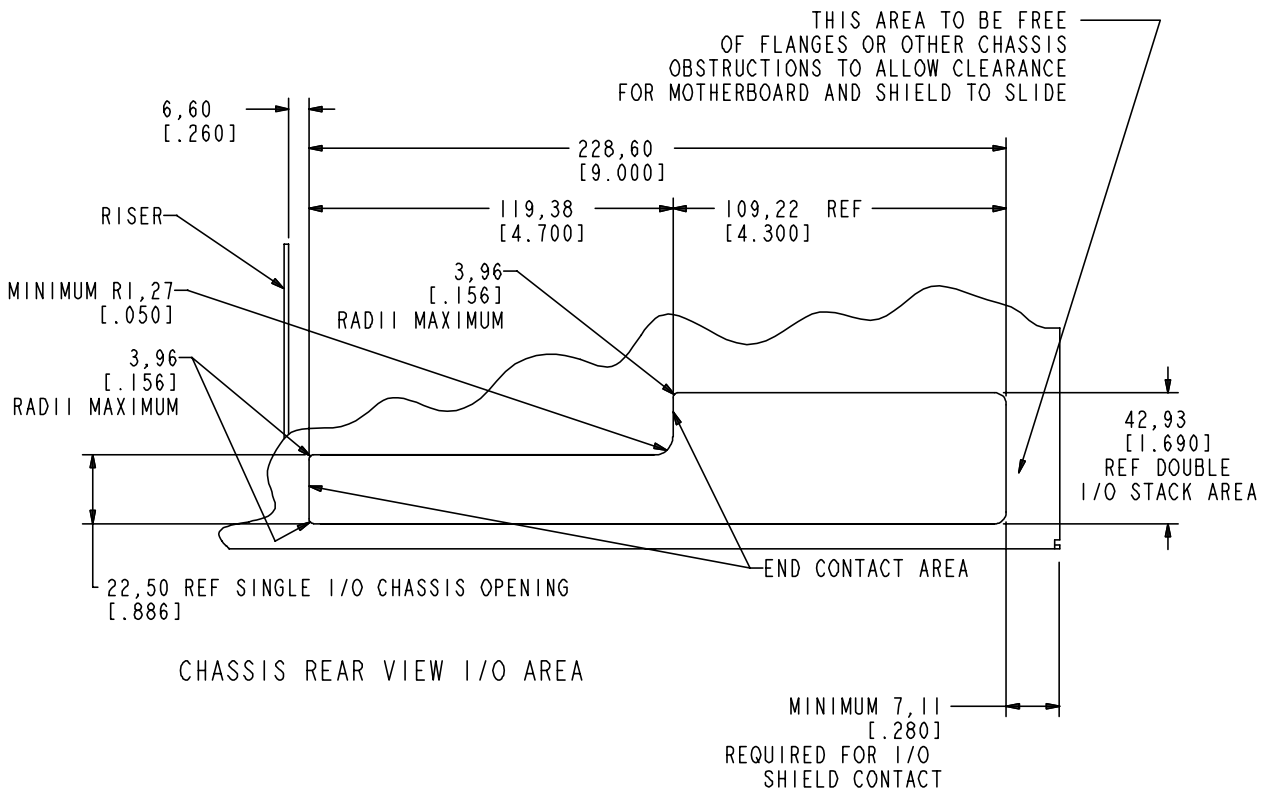
Figure 3.17: Chassis Back Panel I/O Shield Opening

The figure as shown in version 1.2 of the specification has incorrect corners for the I/O aperture. If a chassis vendor were to develop a chassis to this diagram, it would introduce unnecessary complications.

Change Figure 3.17 to correct the drawing.

Replace Figure 3.17 with the following diagram.
